# REFURB SOLUTION EXTENDS LIFE OF EQUIPMENT

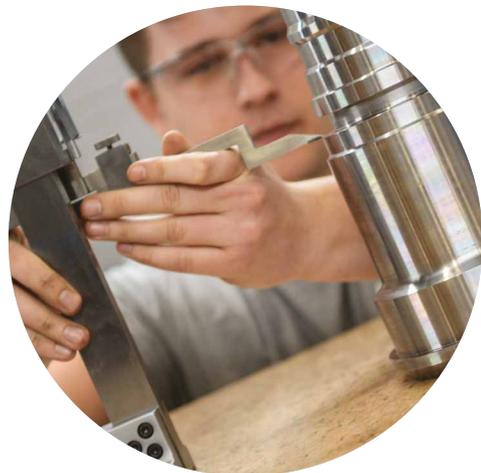
An oilfield service company approached Probe to complete a full visual and dimensional inspection on a 13<sup>5</sup>/<sub>8</sub>" – 5000 Bowl – 7100 Tall. The component was badly corroded on all sealing areas.

"As part of the refurbishment, all the sealing surfaces were rough machined to oversize allowing an Inconel weld inlay to be installed over the sealing area," said Dave Good. "Once this operation was completed, the Inconel inlay was machined back to the specification required for the sealing face, which ensured that the component still met with the required manufacturing tolerances. The internal areas were then inlaid with Inconel to help prevent further corrosion for when the component will be used in extreme environments."

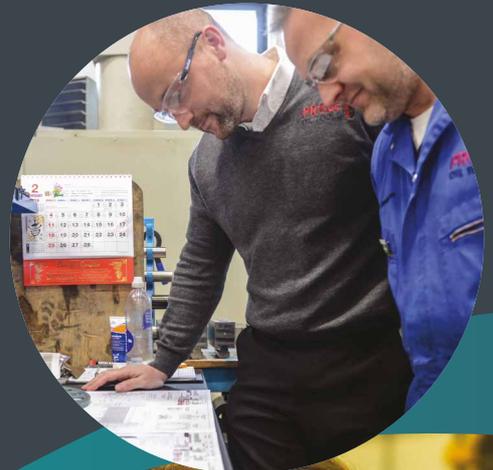
Probe provided a full in-house inspection, recommendations, refurbishment, machining and testing service. All components were fully recertified to the specified requirements and the final product was supplied painted to the client's design expectations and requirements.
